WP 6 – Action 6.2 – State of the art report

Hazards related to permafrost and to permafrost degradation

Local ground movements and effects on infrastructures

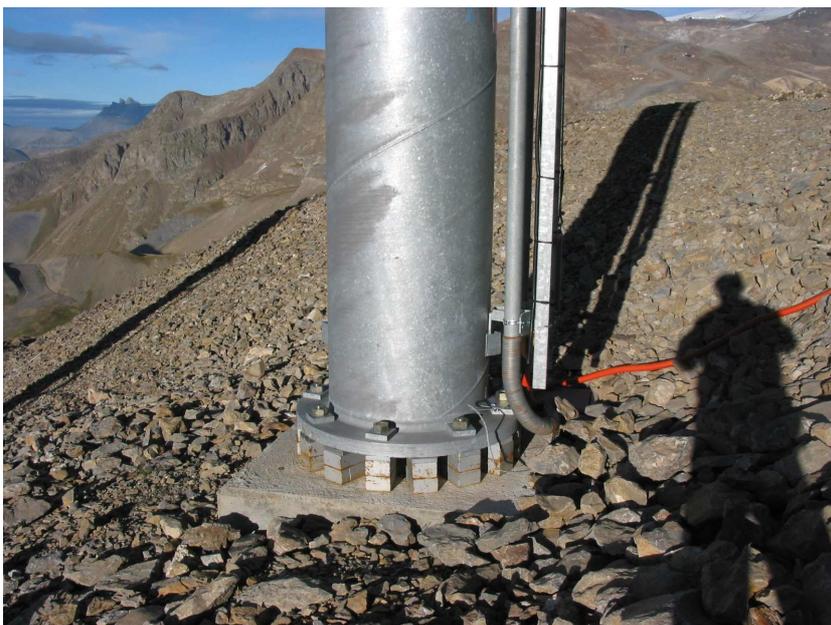
Fig. 4.1 – Chairlift pylon on a rockglacier. Subsidence due to movements and possibly ice melting necessitated adjustment of the pylon by intercalating metal pieces at the base. Adjustment capacity of the screws is exhausted, and any further vertical settling will need partial rebuilding of the pylon.

If one or more pylons are on a moving permafrost body, problems very similar to those known on slides will occur. The movements of the pylons will disturb the alignment of the cable, needing periodic (usually annual) control and corrections, increasing annual maintenance costs. If small movements can be accommodated by technical adjustments, larger cumulated movements can lead to the necessity of partial or total rebuilding, or even to the abandon of the cableway.

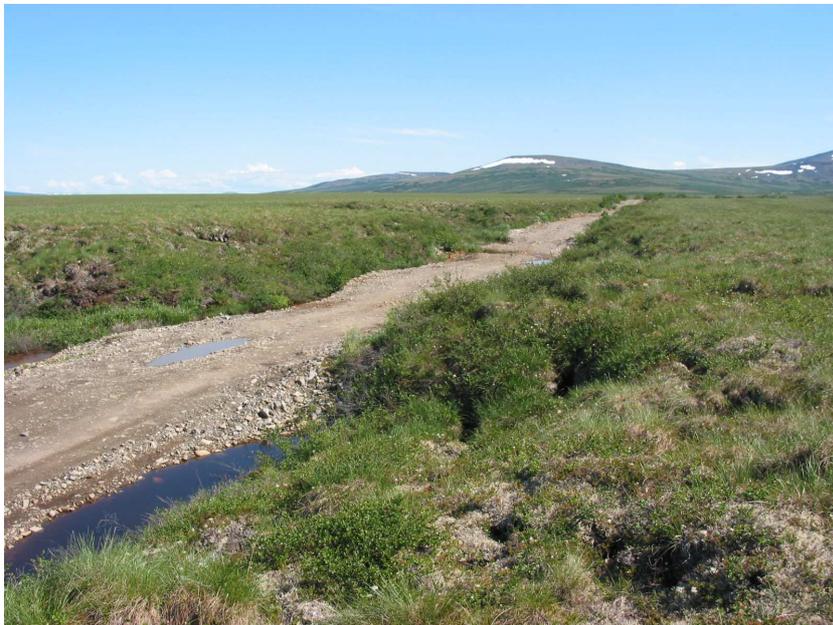
Fig. 4.2 – Road subsidence in the Seward Peninsula, Alaska. The road altered the thermal regime of the active layer and induced melting of the underlying permafrost. It lies now more than a meter below the initial ground surface. Ponds form where the road crosses ice-wedges (photo P. Schoeneich).

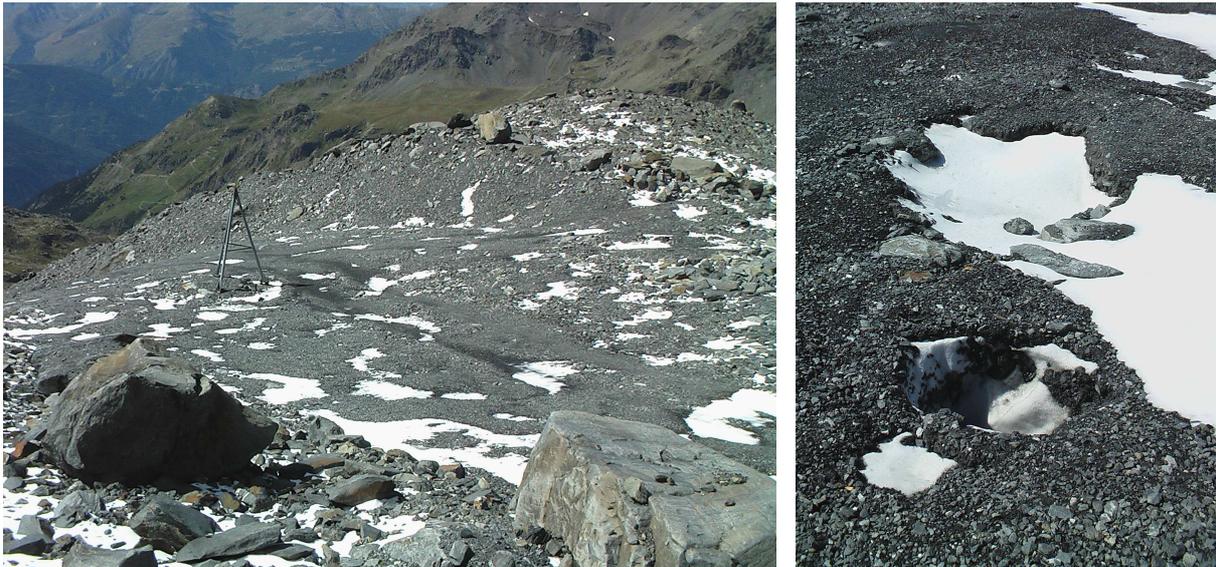
Fig. 4.3 – Ski track planated across the rockglacier complex Le Bouchet (ski resort Orelle, France). The track serves also as access road to the chairlift end station. The snow patches on the track reveal thermokarst features, induced by the removal of the coarse blocky surface layer. Right: detail of a thermokarst hollow. (photos P. Schoeneich, august 2010)

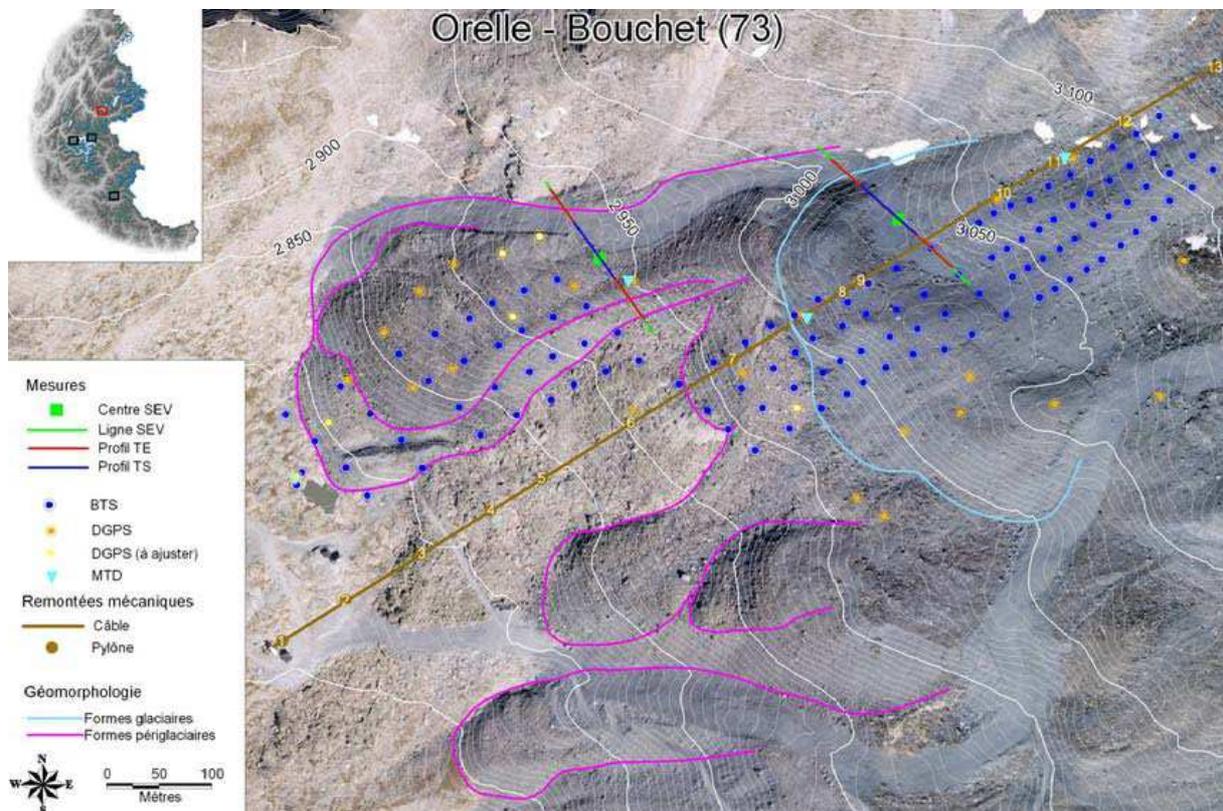
Fig. 4.4 – The Bouchet chairlift. Pylons 3 to 6 are on deeply shattered and creeping bedrock, pylons 6 to 11 are on a rock-glacier. Figure indicates the monitoring points and profiles.

Within the Plan Bouchet ski resort (Orelle, Savoie), the Bouchet chairlift is partially built on a rock-glacier: start and end stations are on bedrock, but five pylons are on a moderately active rock-glacier in the middle part, and four pylons are on deeply frost shattered and creeping bedrock in the lower part.

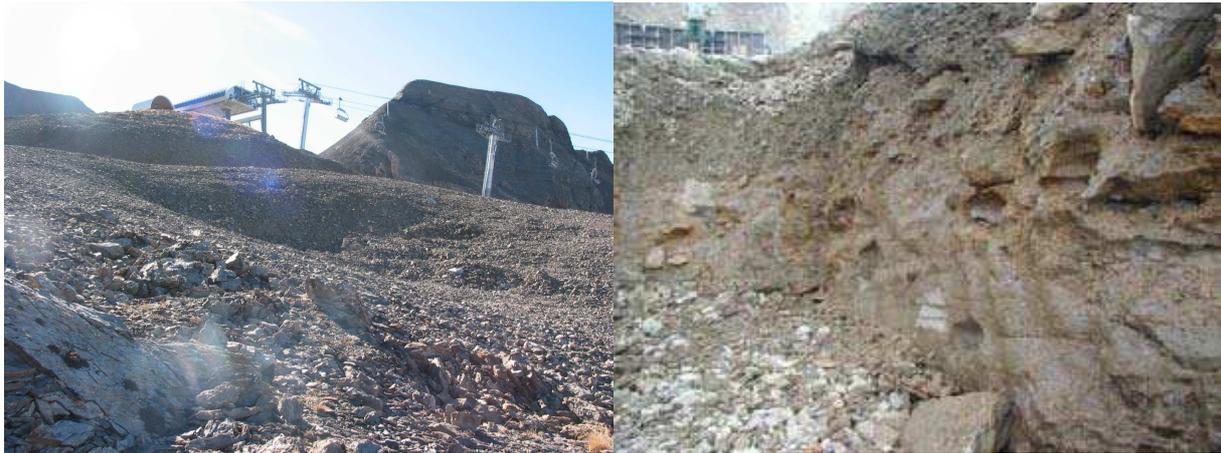
Fig. 4.5 – Left : the top of the Bellecombes chairlift, with the last pylons and the end station on a rockglacier. Right : ice layer found at 4 m depth during construction of the end station.

A 2 to 4 m thick ice lens was encountered below a 4 m thick coarse blocky layer during foundation excavation of the end station, and totally removed.

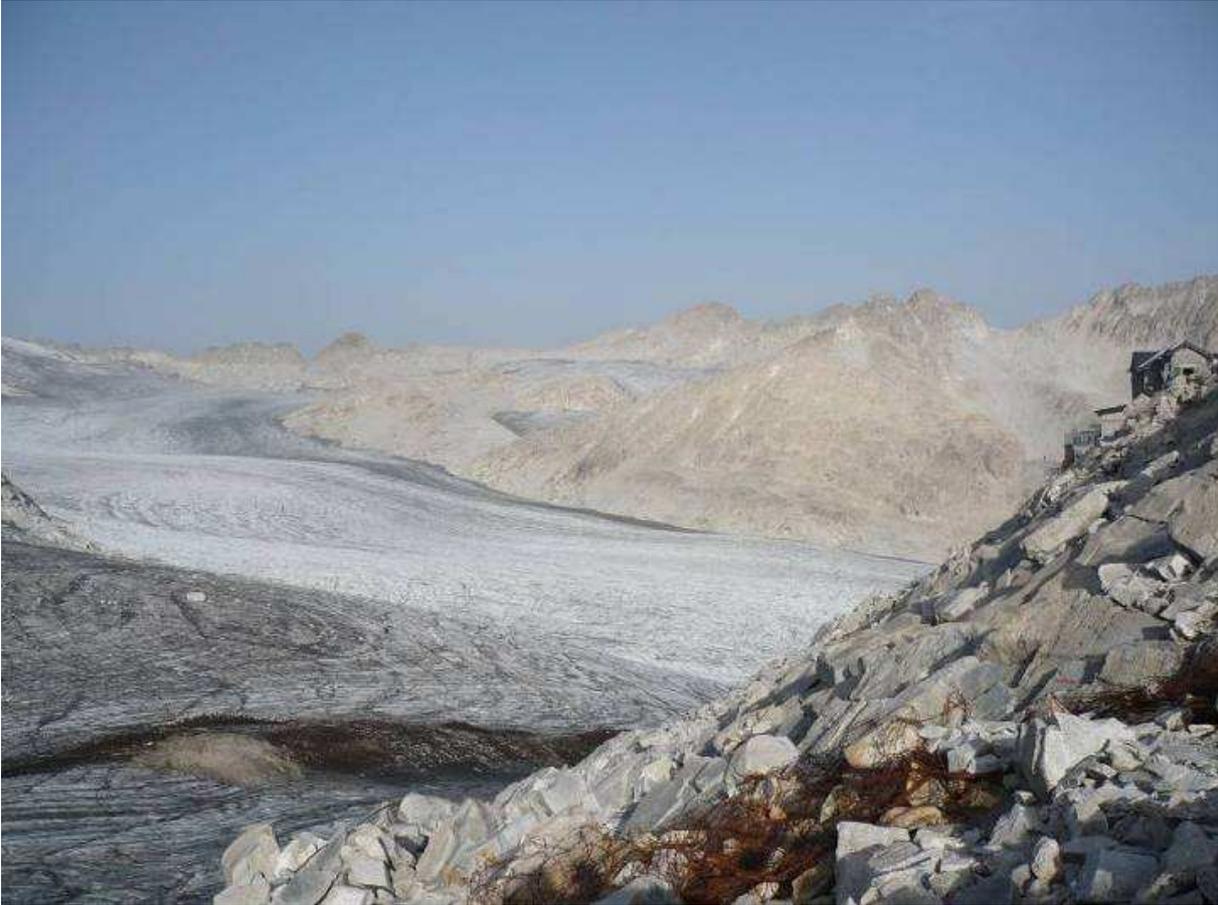
Fig. 4.6 – Alpine refuge "Ai Caduti dell'Adamello" 3030m lies on a slope subject to local ground movements.

GST-PAT has started the monitoring of “Rifugio Ai Caduti dell'Adamello”, a high elevation alpine refuge in the Adamello-Presanella massif in the central Alps (see Fig. 4.6). The refuge is located on a slope and is affected by local ground movements and consequent instability of the building.

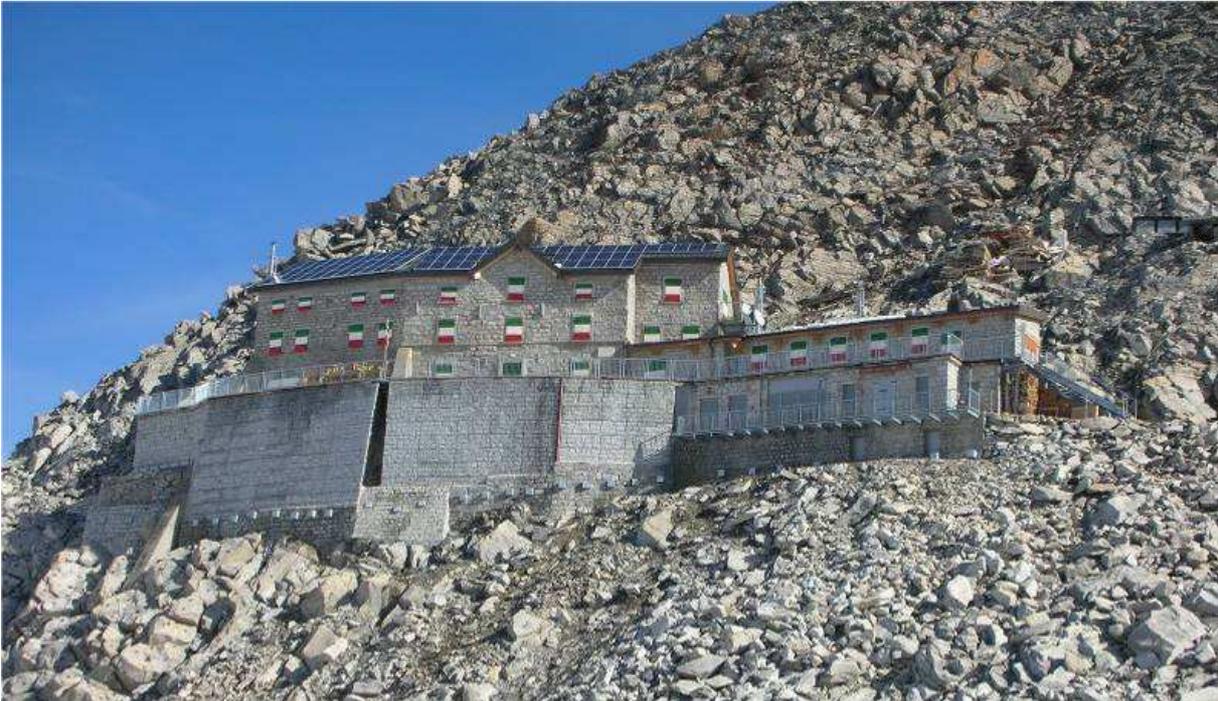
Fig. 4.7 – Front view of the refuge

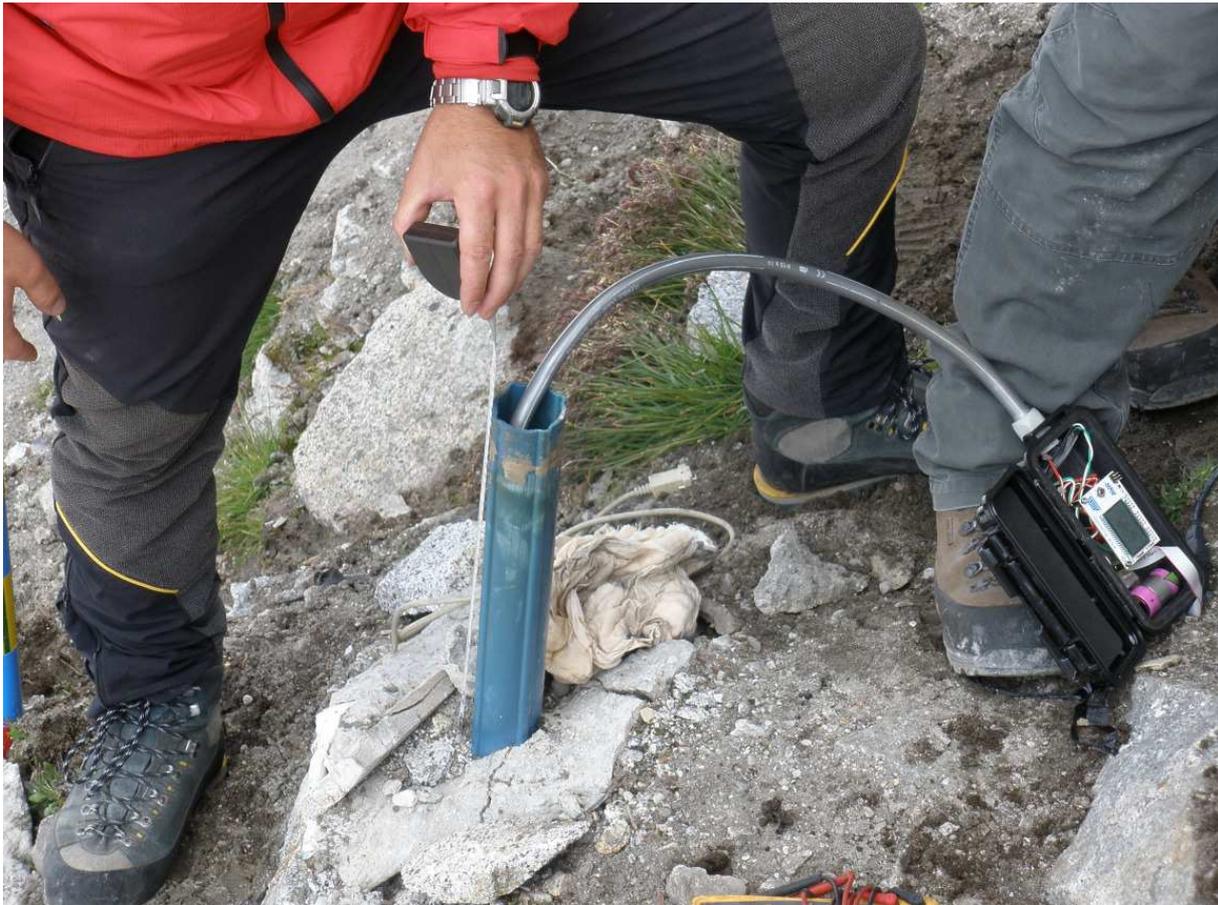
Fig. 4.8 – Inclinometer borehole is being equipped by a thermistor chain with data-logger.

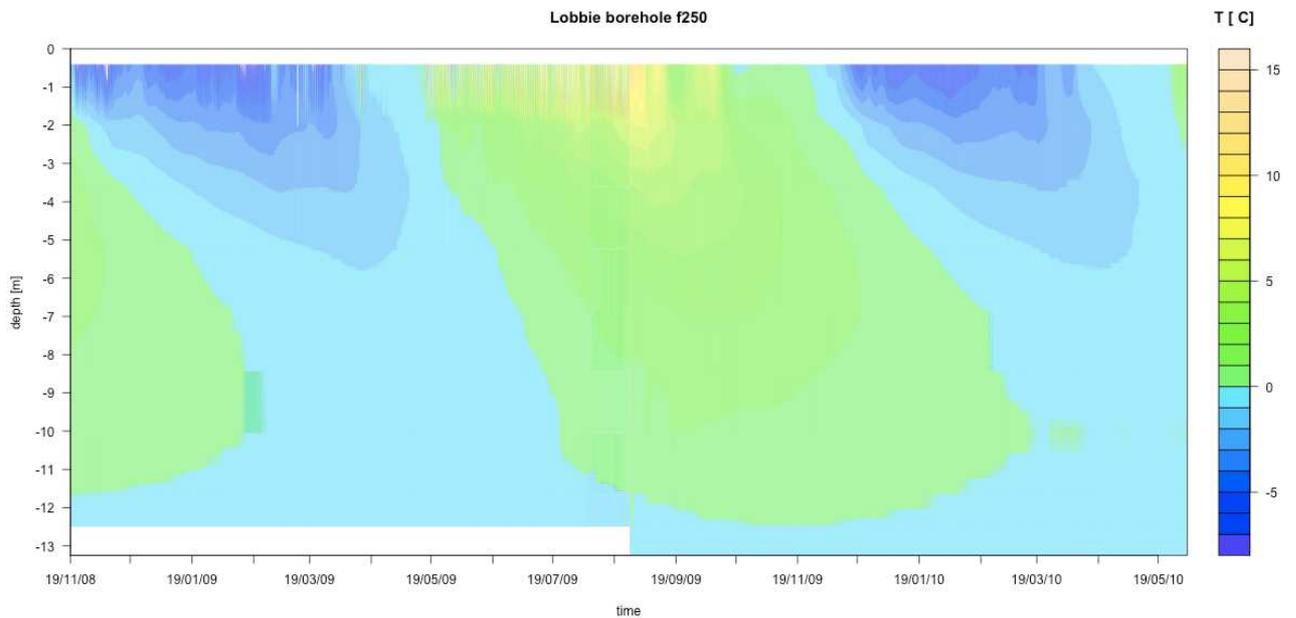
Fig. 4.9 – Thermal profile of the ground at the borehole. The colours indicate the temperature at a particular date and depth

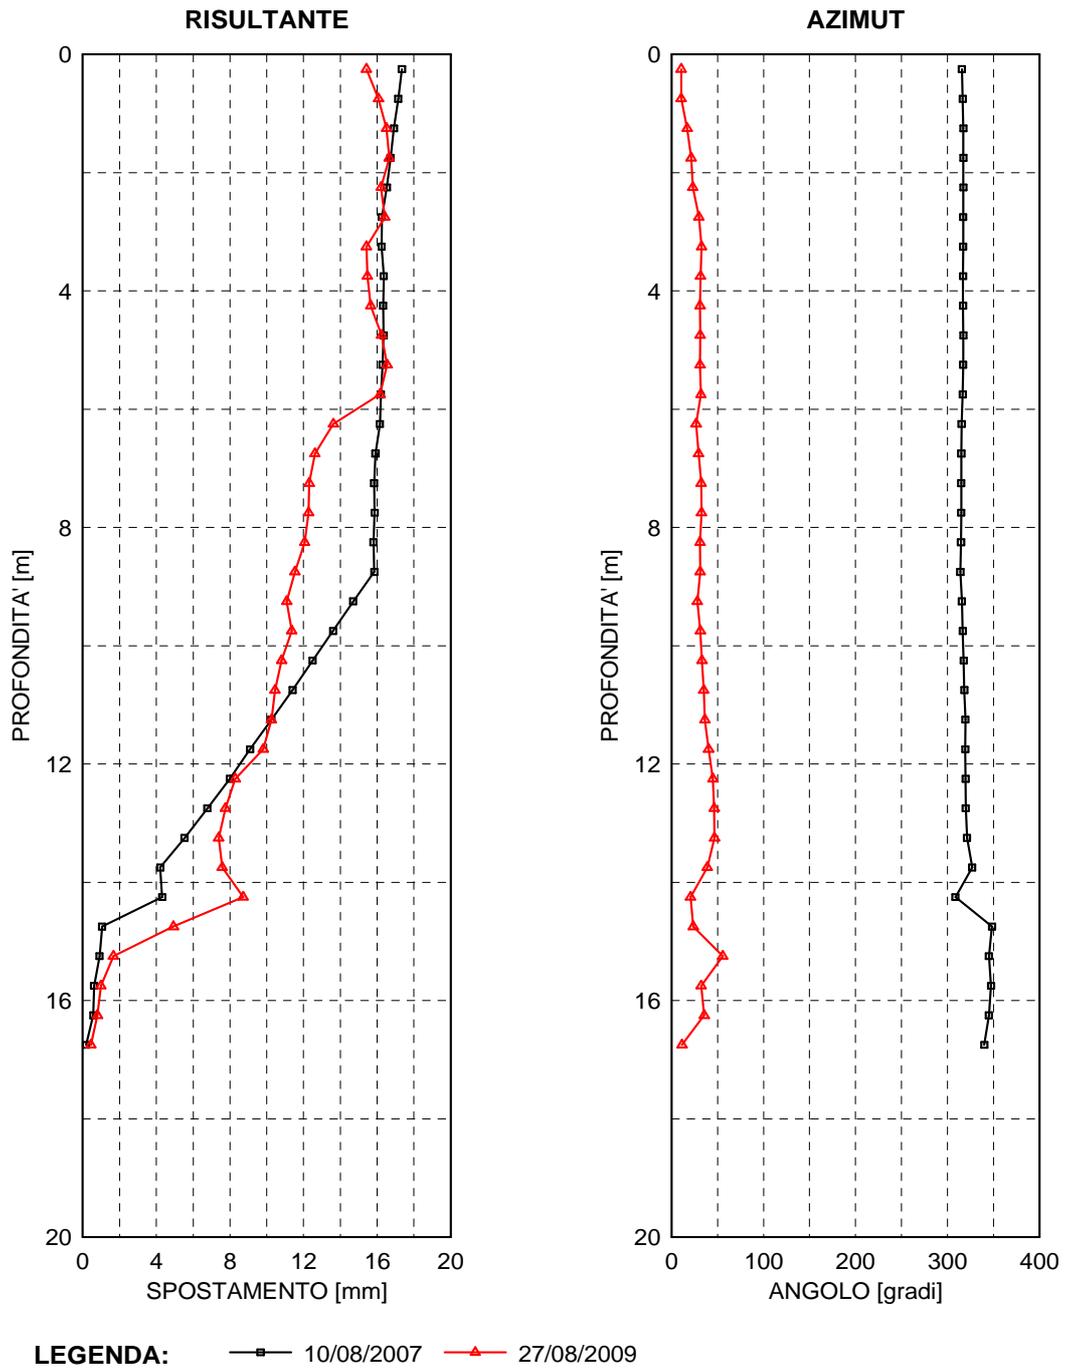
Fig.4.10 – Inclinometric surveys in one of the boreholes at “Ai Caduti dell’Adamello” site

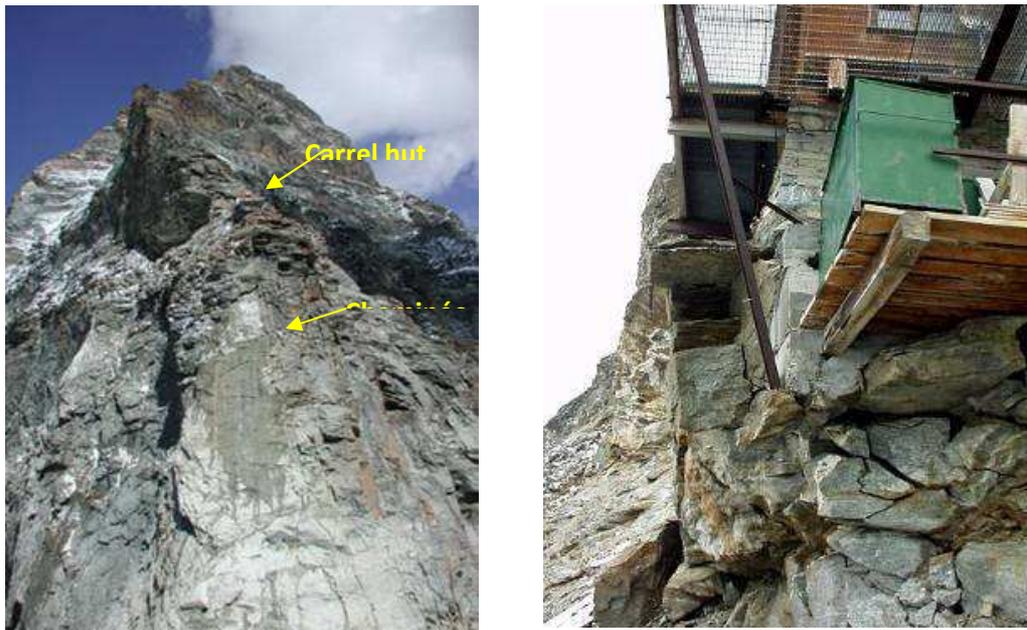
Fig. 4.12 – Left: The Cheminée after the rockfall of 19/08/2003. The water below the Cheminée comes from the melting of the ice lens uncovered by the rockfall.. Right: Rock mass under the hut basement after the Cheminée rockfall.

The Carrel Hut is located on a very fractured rock spur on the SW ridge of Matterhorn. During the very hot summer 2003 the building basement underwent some deformations, and small rockfalls from the sectors above the Hut occurred. In particular after the Cheminée rockfall of 19th August 2003 (80 m below the building) the rock mass where the hut is based showed some joints widening causing the destabilization of the basement.

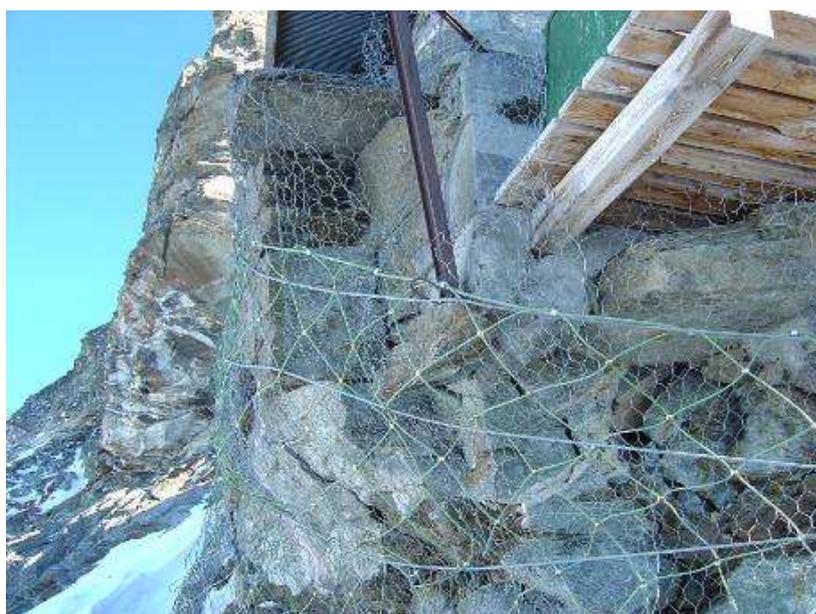
Fig. 4.13 – Consolidation of the rock mass below the Carrel Hut basement.

Furthermore, a metal structure based on the rocks beneath the spur was constructed: three lattices founded with anchor rods contrast the rock mass bound by the net.

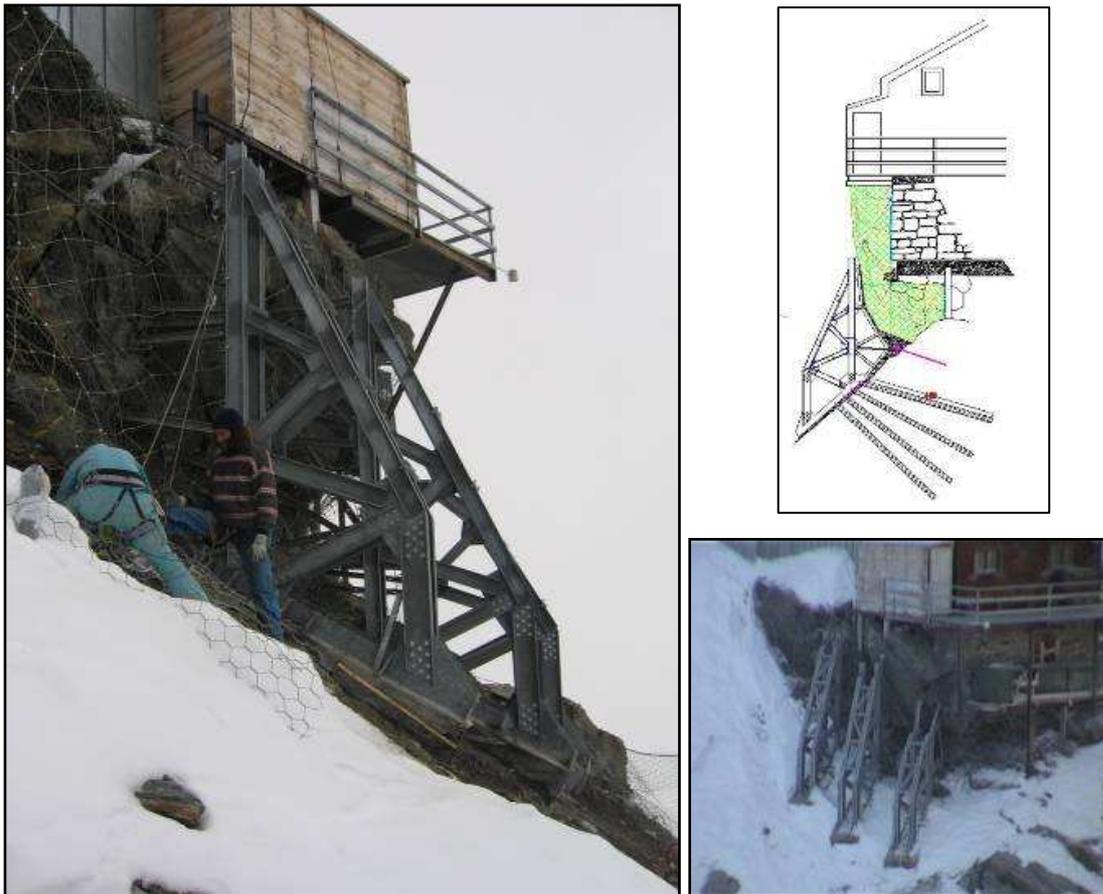
Fig. 4.14 – View of lattices contrasting the rock mass bound by nets beneath the hut basement (photos by Società Guide del Cervino – L. Trucco).

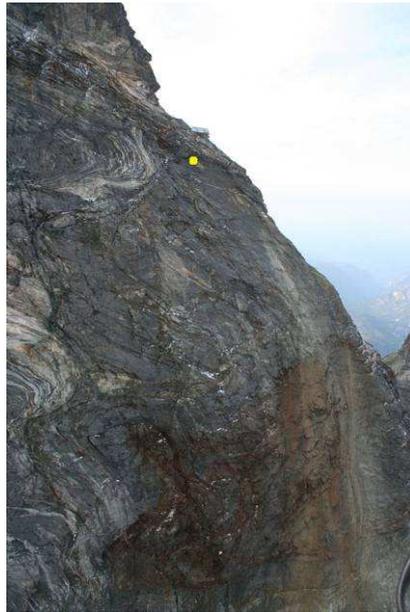
Fig. 4.15 – Rockfall scar of 2006 event in the lower right corner, about one hundred meters below the Carrel hut. The yellow dot is the position of the rock temperature sensor (photo RAVA).

In summer 2006 (25/07/2006) another rockfall occurred along the North West side of Matterhorn about 80-100 m below the Carrel Hut. The fall was heard by the people in the hut and made the hut shaking but no damages arrived at the structure. Rock temperature measurements recorded by ARPA Valle d'Aosta few tens meters above the rockfall scar showed that the event occurred during the hottest period of the summer 2006 (see plot), during which the minimum daily temperature (blue line) was above 0°C for several consecutive days.

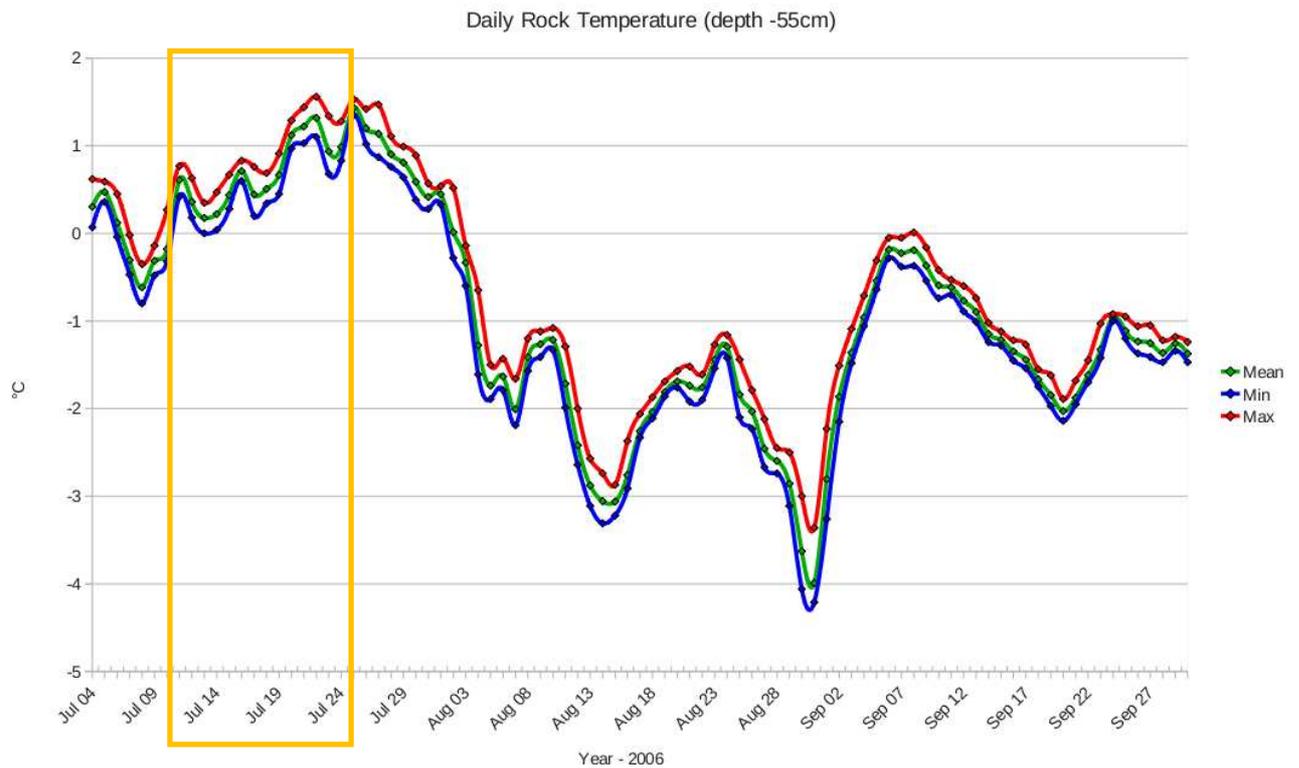
Fig. 4.16 – Daily rock temperature measured on the NW side of Matterhorn during summer 2006; the yellow box shows the temperatures above 0°C recorded before the rockfall of 25/07/2006. The measure is performed at 55 cm depth. Red line: maximum daily rock temperature; green line: mean daily rock temperature; blue line: minimum daily rock temperature.

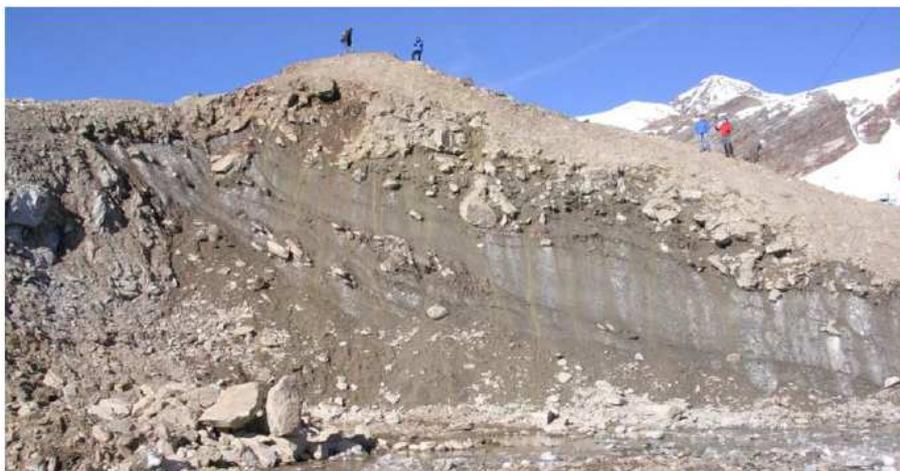
Fig. 4.18 - Ice lens found during the excavations for the foundation of the central pylon (Monterosa SpA).

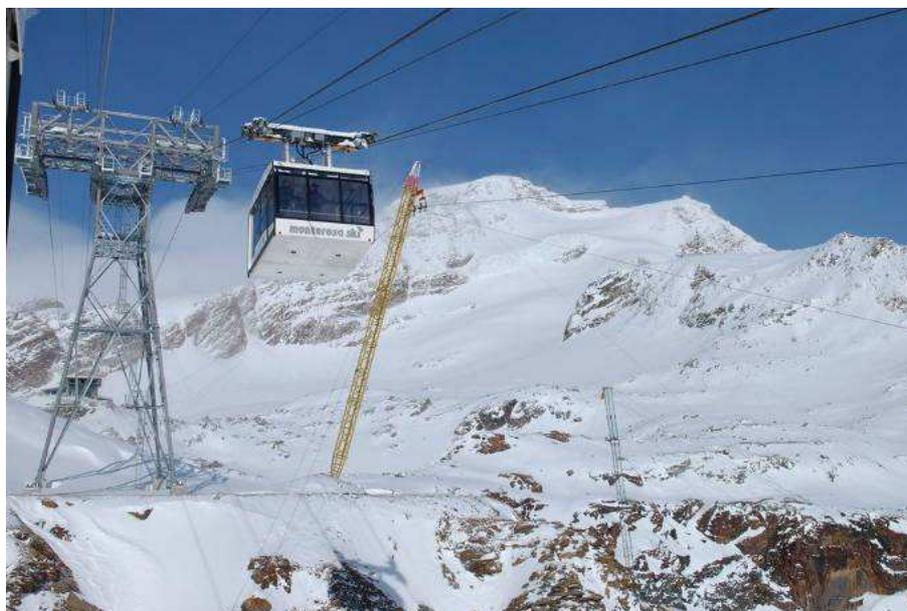
Fig. 4.19 - View of the pylon (R. Pircher, www.funivie.org).

The pylon works ended in Autumn 2008 and the cableway was opened in 2009 (Fig. 4.19).

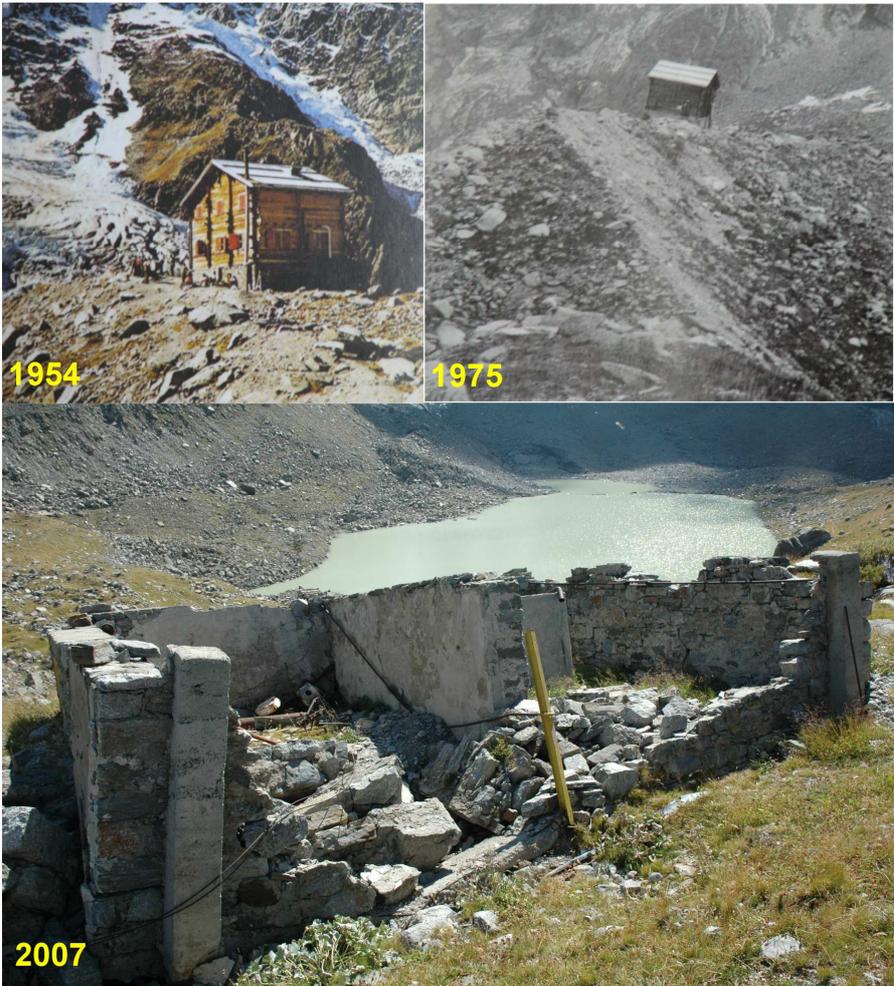
Fig. 4.22 – Rifugio Paradiso some days after its opening (1954, Mortara & Tamburini, 2009), in the middle 70's in which structure inclination is quite evident (1975, Mortara & Tamburini, 2009) and the ruins of the concrete platform with guy ropes as visible today (2007, photo by L. Paro, Arpa Piemonte)

The influence of the ice presence is also recognizable in the case of structure instability of Rifugio Paradiso on the frontal moraine ridge of Locce glacier (Fig. 4.22). In order to advance the hypothesis of permafrost “degradation”, one should first of all verify the origin of the ice, i.e. derived from the glacier or self imposed (sedimentary or pore ice). Haeberli and Epifani (1986) suggest that the ice should derive from buried glacier ice. In any case, the ice melting in the till caused the slope instability and the abandon of the inclined alpine shelter. Probably the concrete platform of the shelter base increased the permafrost degradation velocity. The geo-electric analyses carried out in the 1980's (VAW-ETH of Zurich, Switzerland) and in 2007÷2008 (Insubria University, Italy) on the till of Locce moraine underline indirectly the trend to permafrost degradation, causing the melting of some meters of the frost layer (personal communication by M. Guglielmin). The NW side of the same moraine of the Locce glacier highlights a landslide process since 2005. The laser-scanner analyses carried out between 2005 and 2006 indicate velocity of debris slide and flow of about 36 m y^{-1} and the GPR analysis of summer 2007 evidence an “ice core” at $10 \div 20 \text{ m}$ deep in the moraine (Fig. 4.23, Mortara & Tamburini, 2009).

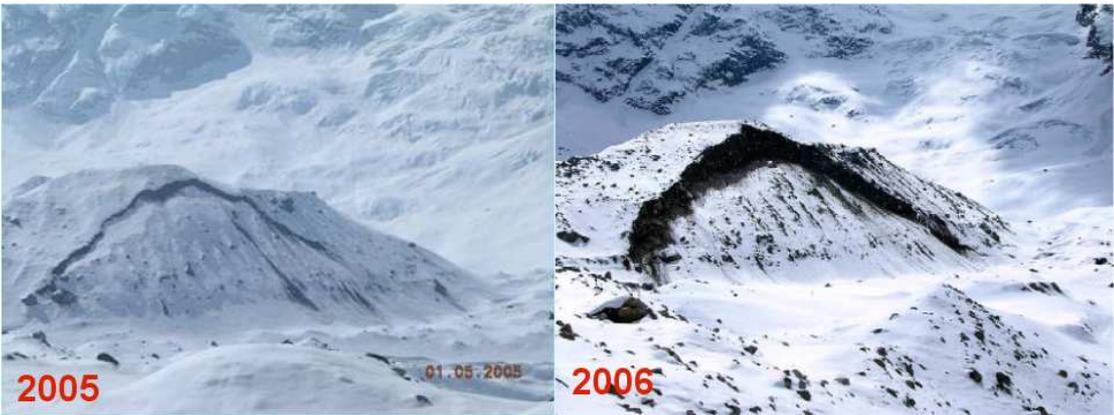
Fig. 4.23 – Landslide evolution in the NW moraine of the Locce glacier (source: Mortara & Tamburini, 2009).

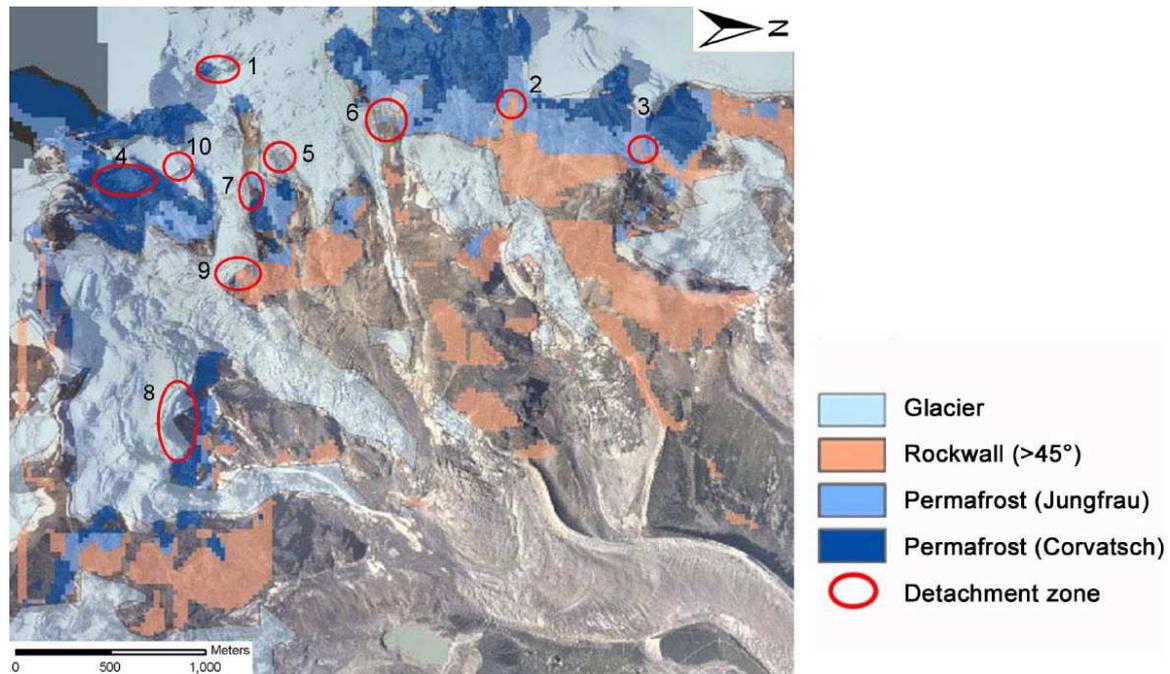
Fig. 4.24 – Permafrost distribution based on the ROCKFROST model (Gruber et al., 2004) with indicated active detachment zones (numbers) (source: Fischer et al., 2006).

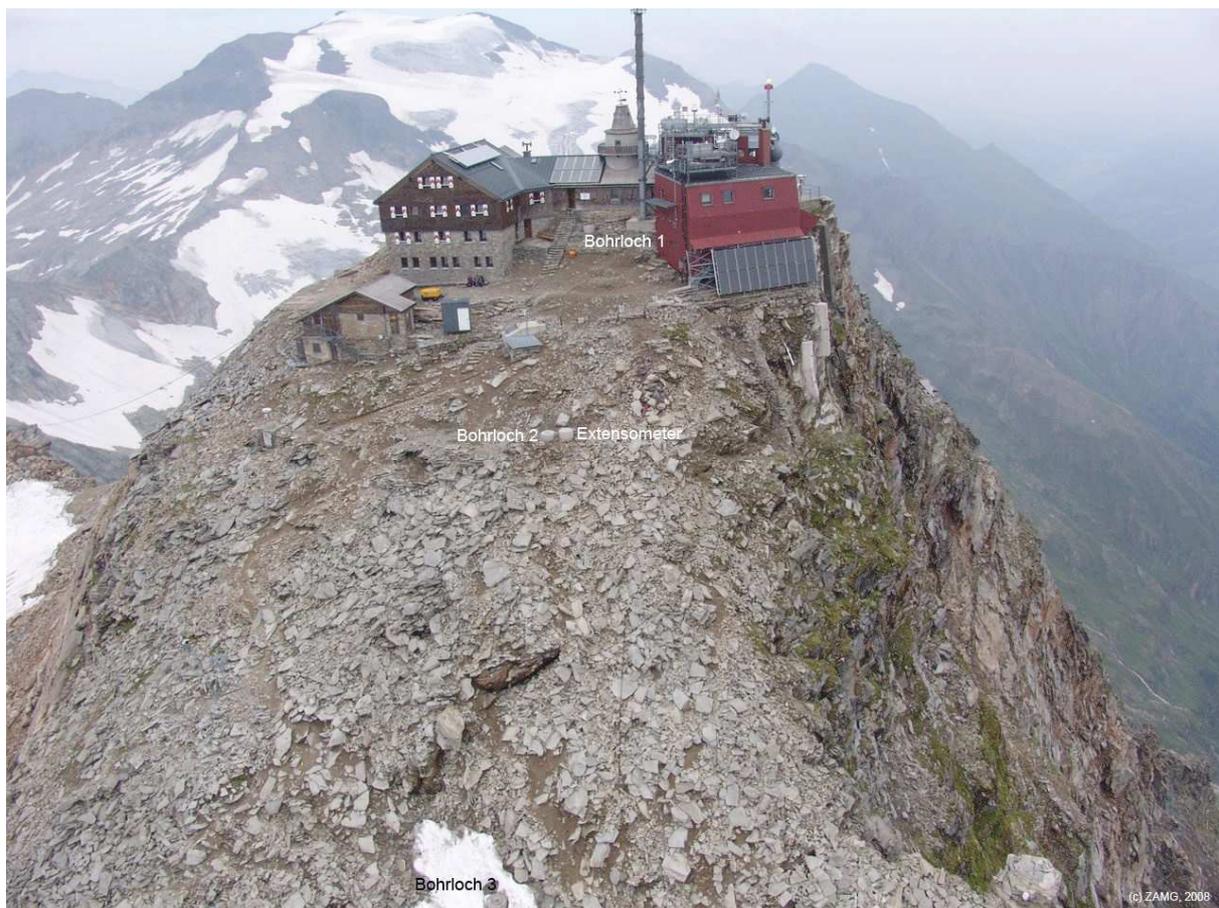
Fig. 4.25 – The summit of Hoher Sonnblick with the exact location of the three boreholes. On the right you see the Zittelhaus, left the Observatorium and in the summit in the background is Hocharn.

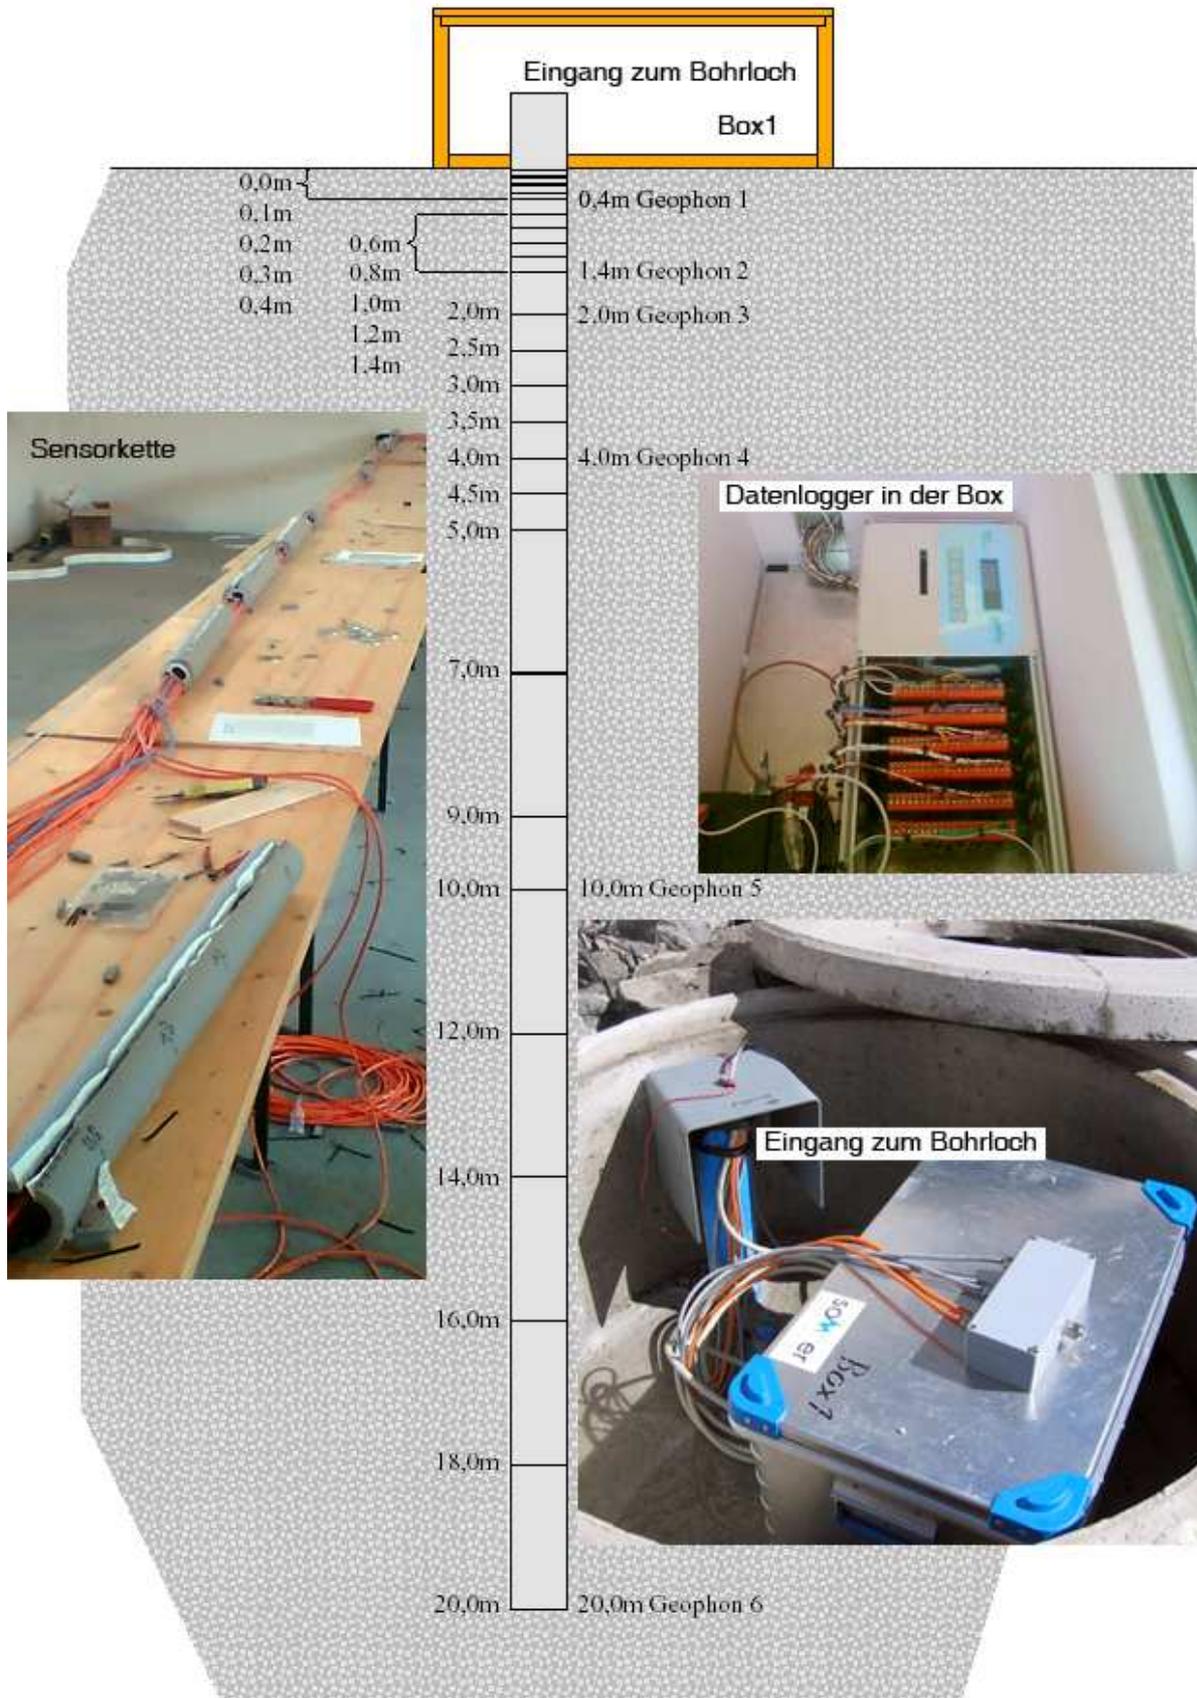
Fig. 4.26 – Construction of measurement chain in the boreholes with depths of the temperature sensors and geophones. Additionally you can see the entrance of the boreholes.

To measure these influences of Permafrost to climate change and the behaviour of Permafrost, on top of Hoher Sonnblick three 20 m deep boreholes were drilled on 14. and 15. September 2005 and were equipped with temperature sensors in different depths (see Figure 4.26) at the end of August 2006. Additionally, one 10 m deep borehole next to borehole 2 was drilled and equipped with extensometers. Daily actualized measurements of temperature data and extensometer data are online available and can be seen on www.sonnblick.net in the internet. All boreholes are located on the southern slope (see Figure 4.25). The mean gradient between borehole 1 and 3 is 27° and the total altitude difference counts 34 m. Borehole 1 is directly located to the Sonnblick observatory, borehole 3 is adjacent to an continuous snow field and borehole 2 is located between both of them.

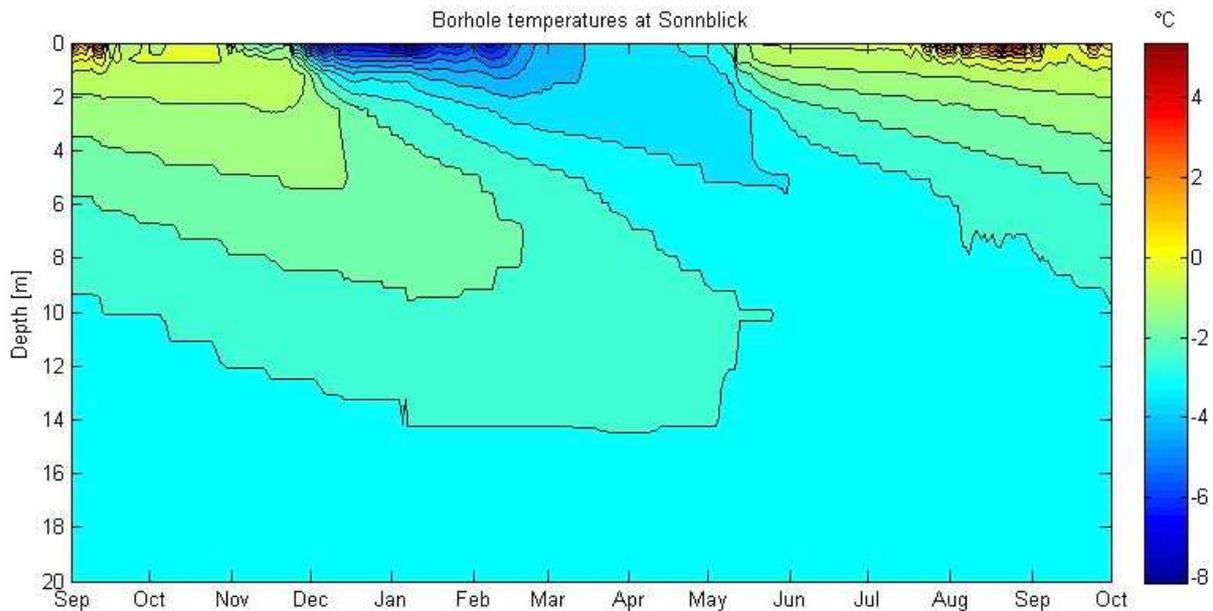
Fig. 4.27 – Temporal temperature variability with increasing depth for borehole 1 during the hydrological year 2007/2008.

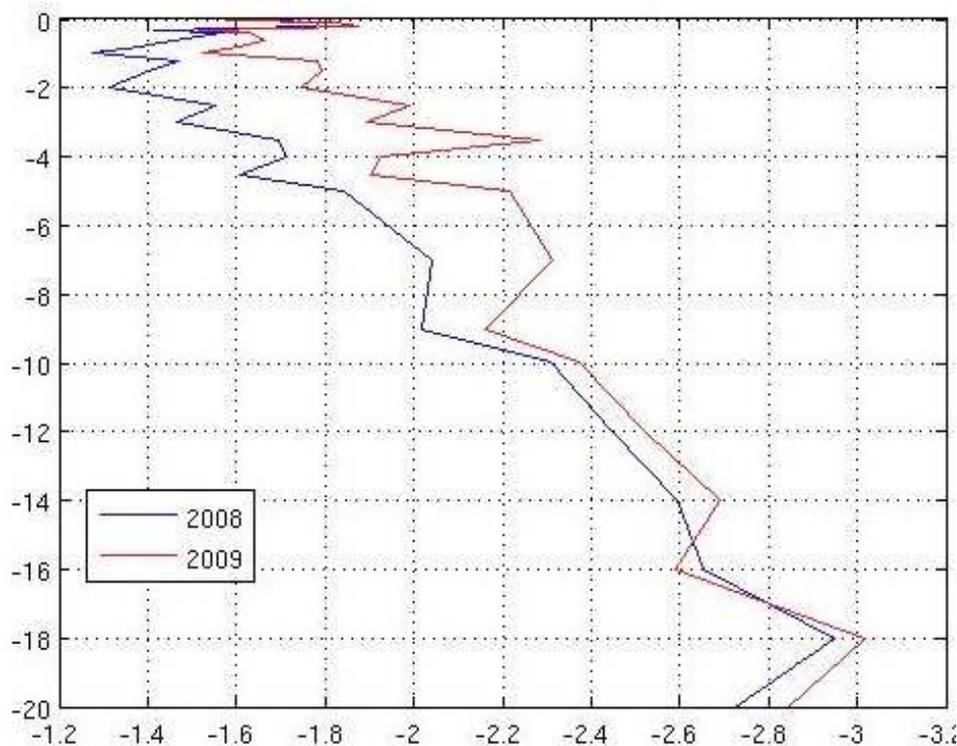
Fig. 4.28 – Mean temperature in 2008 (blue line) and 2009 (red line).

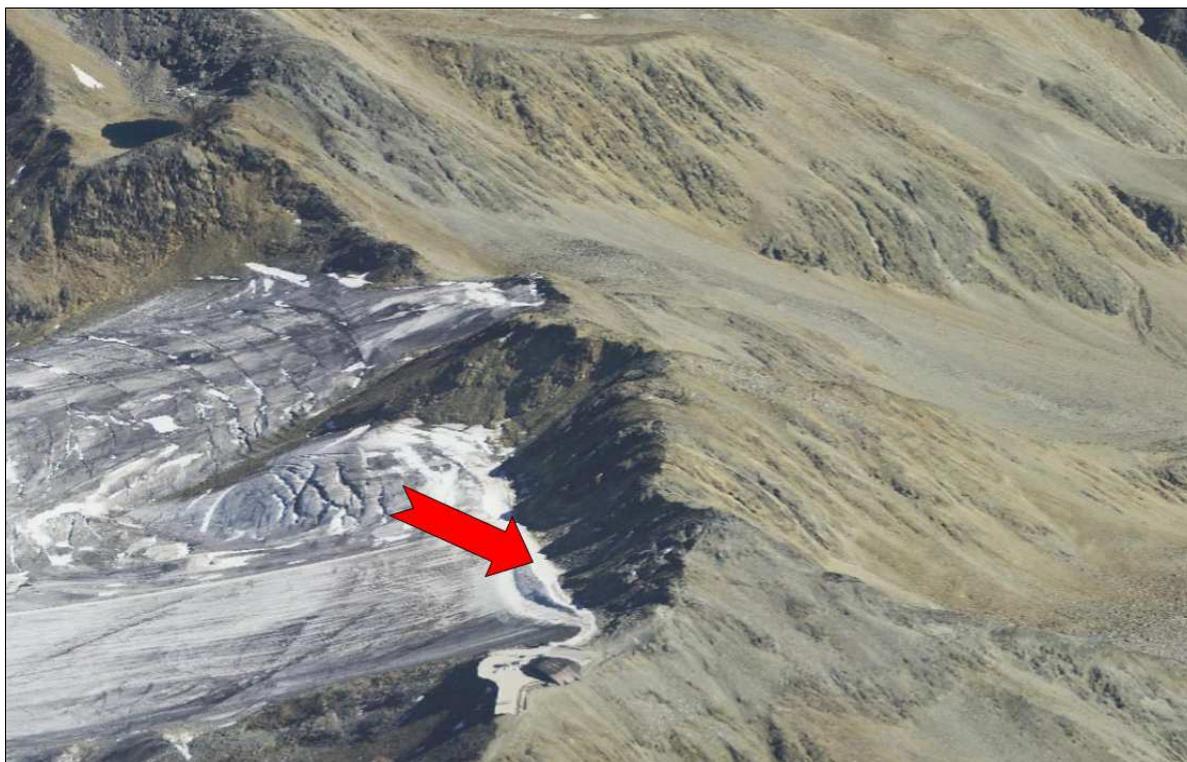
Fig. 4.30 – 3D- view of the Grawand ridge. The red arrow indicates the position of the mouth of boreholes
