WP 6 – Action 6.2 – State of the art report

Hazards related to permafrost and to permafrost degradation

Local ground movements and effects on infrastructures

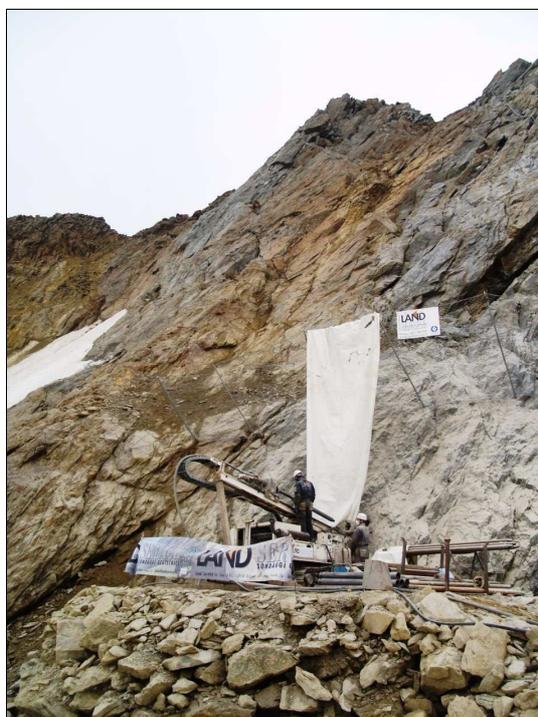
Fig. 4.31 – Drilling site, September 2009.

The ridge of the Grawand – Croda delle Cornacchie (3.251 m a.s.l.) is part of the main chain of the Alps and is located in Schnals valley in South Tyrol (Italy) as shown in Fig. 4.29. The goal of the drilling project, initiated in September 2009 (see Fig. 4.31), was to investigate the problems of rockfall on the glacier ski-trail and problems of stability of the ropeway- structures.

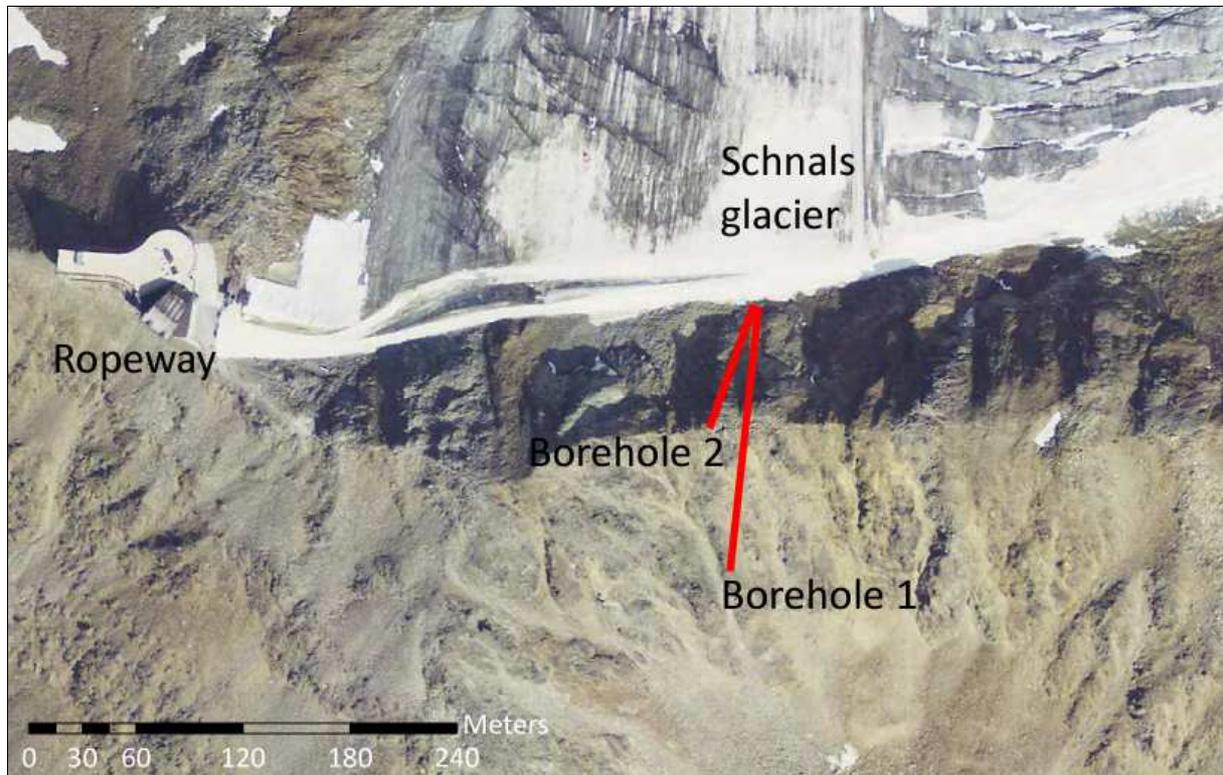
Fig. 4.32 – Location of the two boreholes

The second borehole is oriented north-south and is 162 m long. It reaches the southern face of the Grawand ridge. The borehole is equipped with two thermistor chains in order to measure the temperature profile in the borehole.

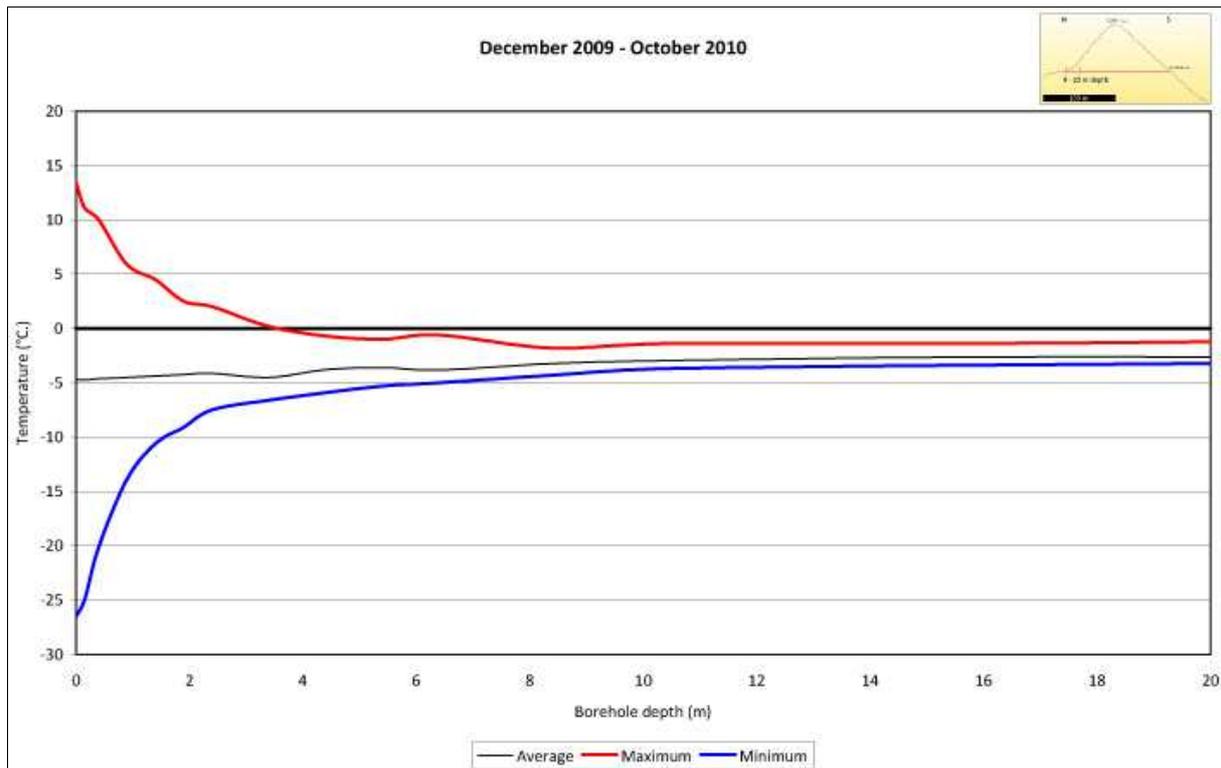
Fig. 4.33 – Minimum, maximum and average temperatures at different borehole depths in the time interval from December 2009 to October 2010. On the north side of Grawand until a depth of 4m the temperatures variate extremely. From 4m the temperatures are more or less constant.

Furthermore it can be observed that on the northern flank from December 2009 to June 2010 the temperature in the borehole remains constantly below zero degrees (≈ -2.6 °C) with little fluctuation.

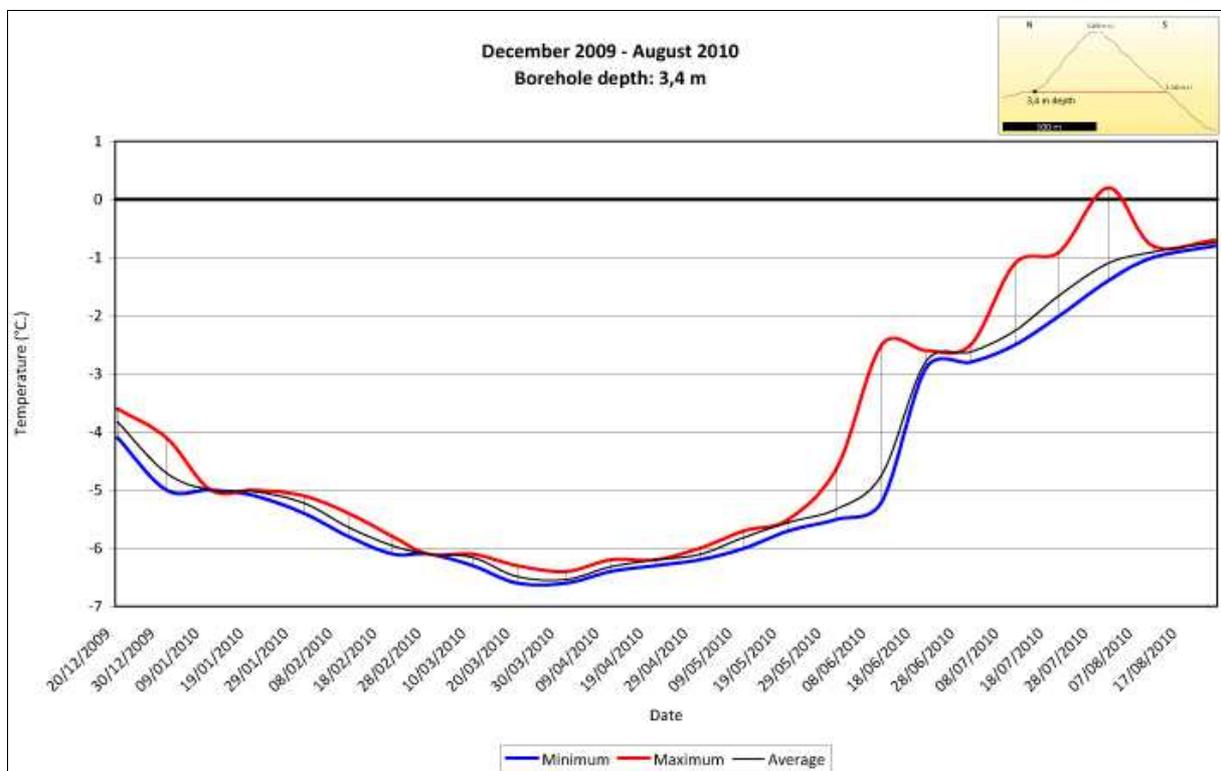
Fig. 4.34 – Minimum, maximum and average temperatures at 3.4m depth (north side) in the time interval from December 2009 to October 2010. In August the maximum temperature measured is slightly above zero degrees.

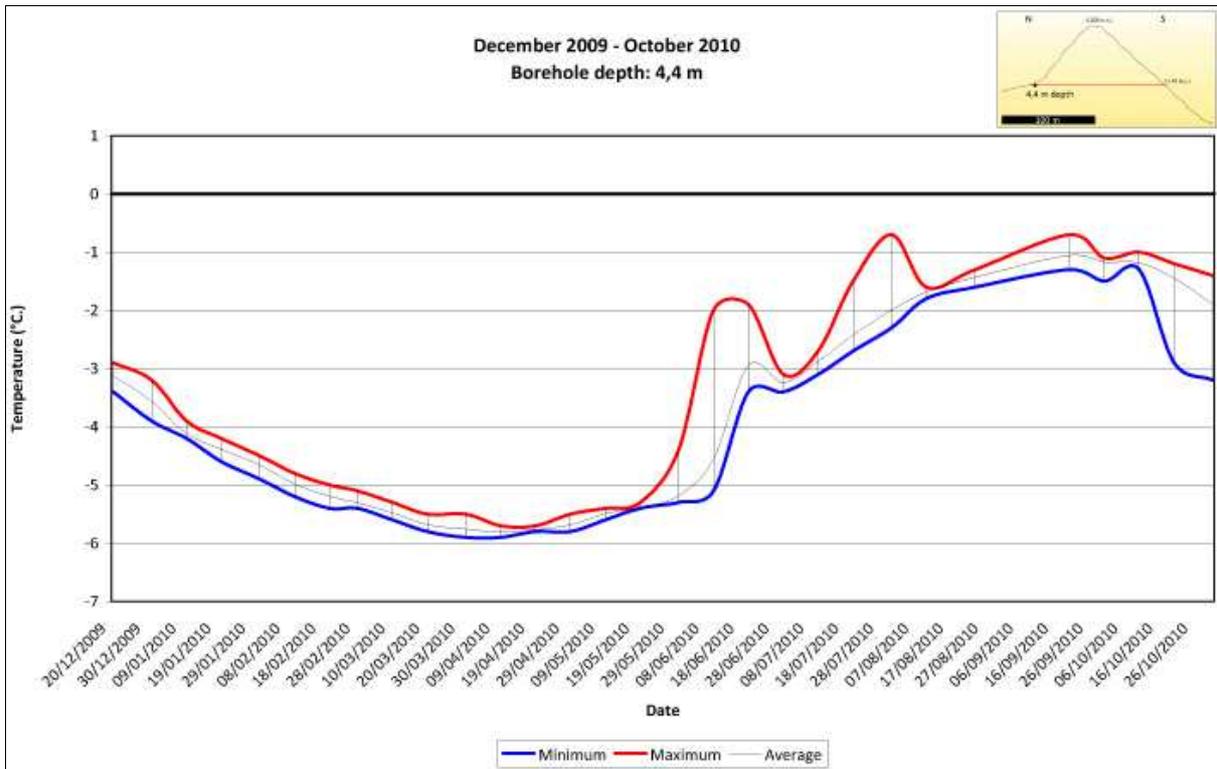
Fig. 4.35 – Minimum, maximum and average temperatures at 4.4m depth (north side) in the time interval from December 2009 to October 2010. From this depth the temperature remains constantly below zero degrees.

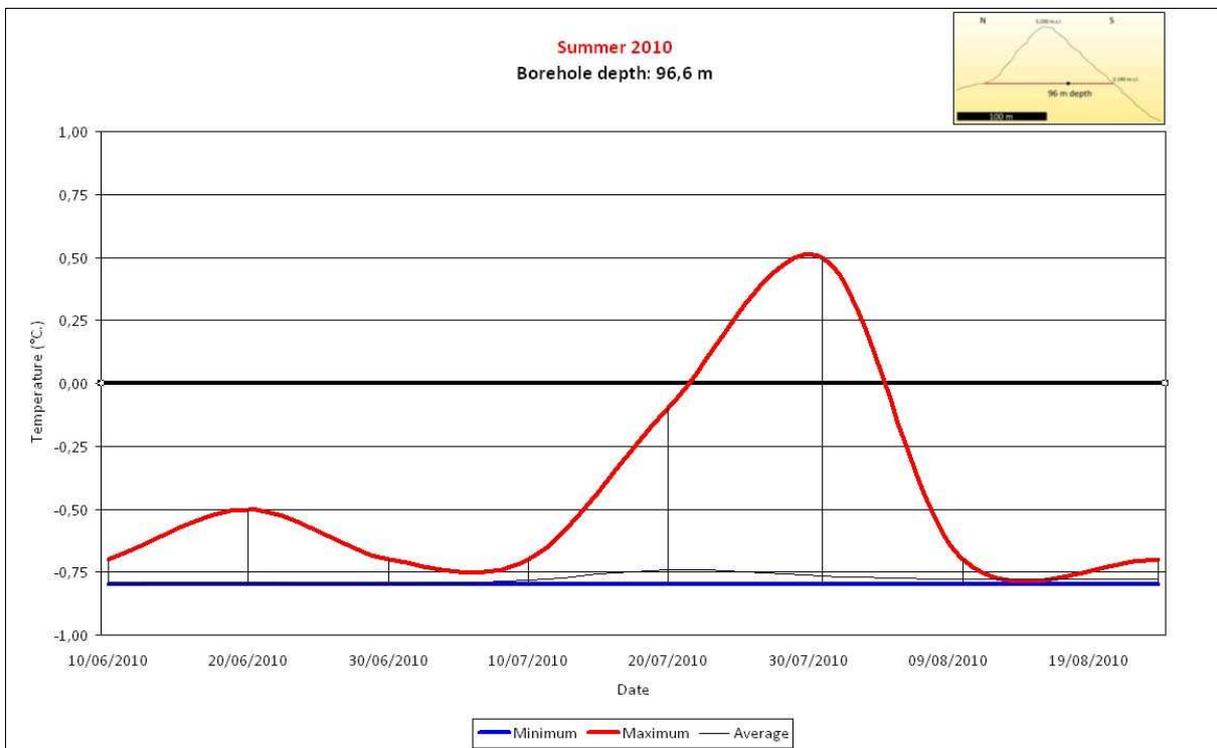
Fig. 4.36 – The temperature rise up to positive degrees during the summer months at a distance of 96m (from northern port) is probably caused by air circulation in rock fractures at this point.

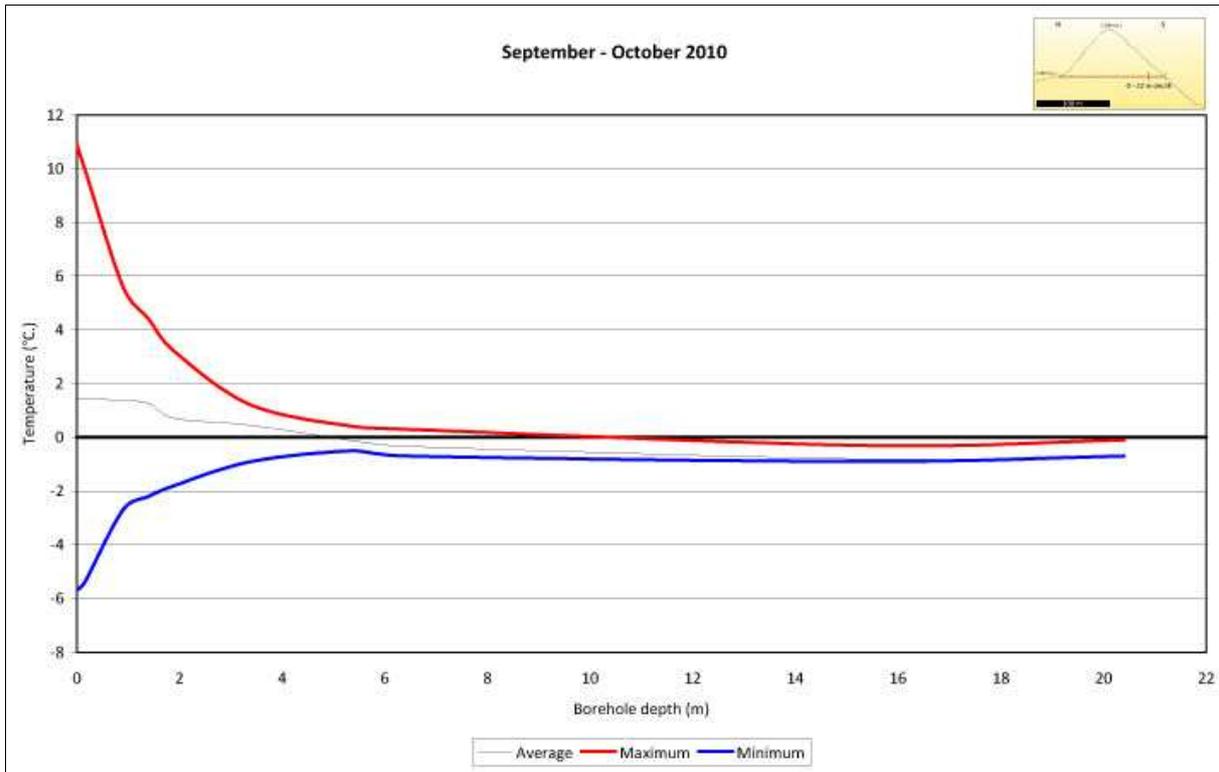
Fig. 4.37 – Minimum, maximum and average temperatures at different borehole distances at the southern side of Grawand ridge. In the time interval from September to October 2010 the temperatures fluctuate extremely until a distance of 5 m from the southern port.

At the southern flank the permanent frozen part seems similar to the northern one. Unfortunately, the dataset of the southern flank is not complete, as the thermistor chain was temporarily out of service.

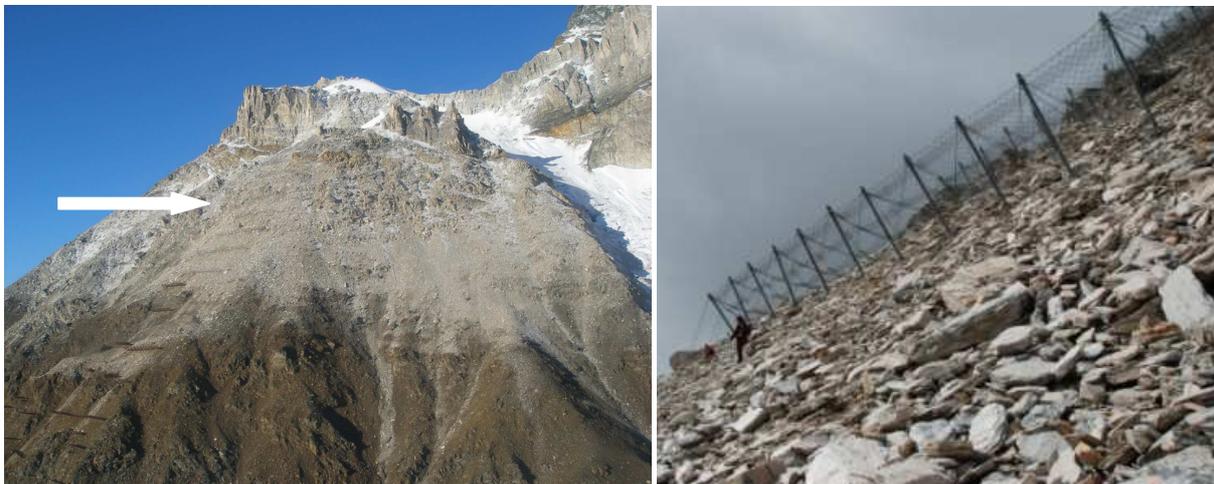
Fig. 4.38 – Eight rows of avalanche defense snow nets at Wisse Schijen (3010-3140 m ASL) in steep permafrost terrain above Randa (Swiss Alps). The snow nets are located in the zone of lighter rock (see arrow, left). Ground cover consists of blocky scree (right) and the mean slope angle is 40°.

Wisse Schijen is a 40° steep avalanche slope located in the Mattertal at 3140 m ASL, above Randa. The slope is equipped with eight rows of flexible snow nets which are 24-45 m long and 4 m high. They were built in 1990-1991 to protect underlying snow bridges, the main road to Zermatt and the village Randa (Fig. 4.38). Ground cover consists of blocky scree, underlain by finer ice-rich sediments and bedrock in which the snow nets are anchored. Technical details on the snow nets can be found in Phillips & Margreth (2008).

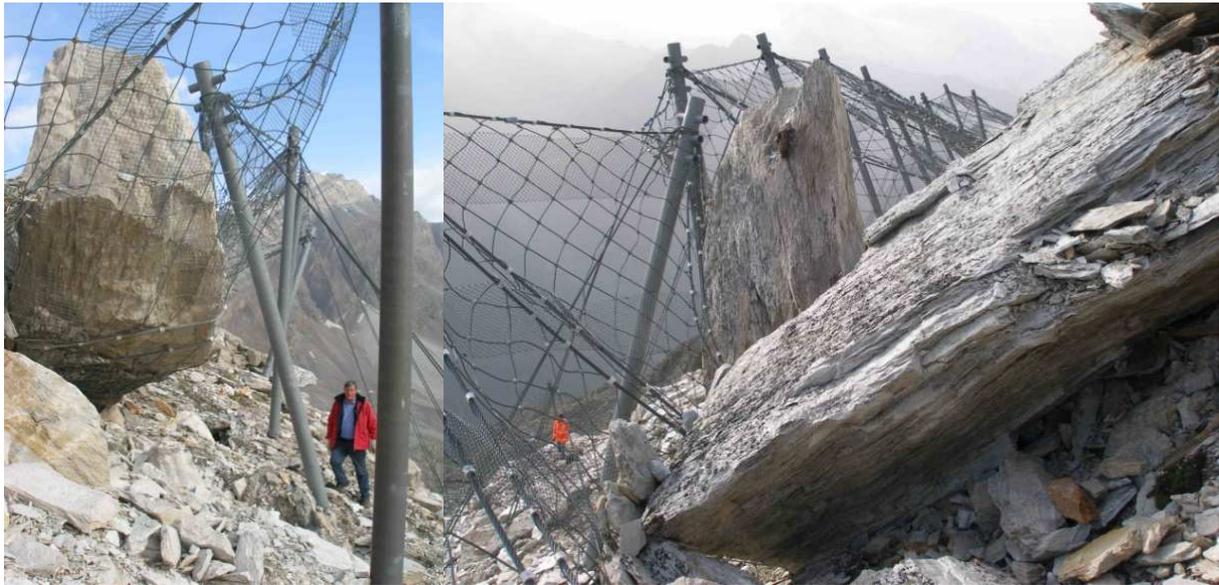
Fig. 4.39 – Rock fall into snow nets at Wisse Schijen in summer 2008.

Originally, the snow nets were not built using specific methods for permafrost conditions and were therefore rapidly subject to the influences of creep, surface erosion, settlement and rock fall. These permafrost-related phenomena induced the disturbance of row geometry, elevated constraints in the superstructure, the dislocation of swivel supports, down-slope tipping of base plates and foundations and may even have led to the buckling or failure of anchors (Figs. 4.39 and 4.40). Major repairs had to be carried out in 2008, after a service life of only 17 years – whereas under normal circumstances the service life of snow nets is around 80 years.

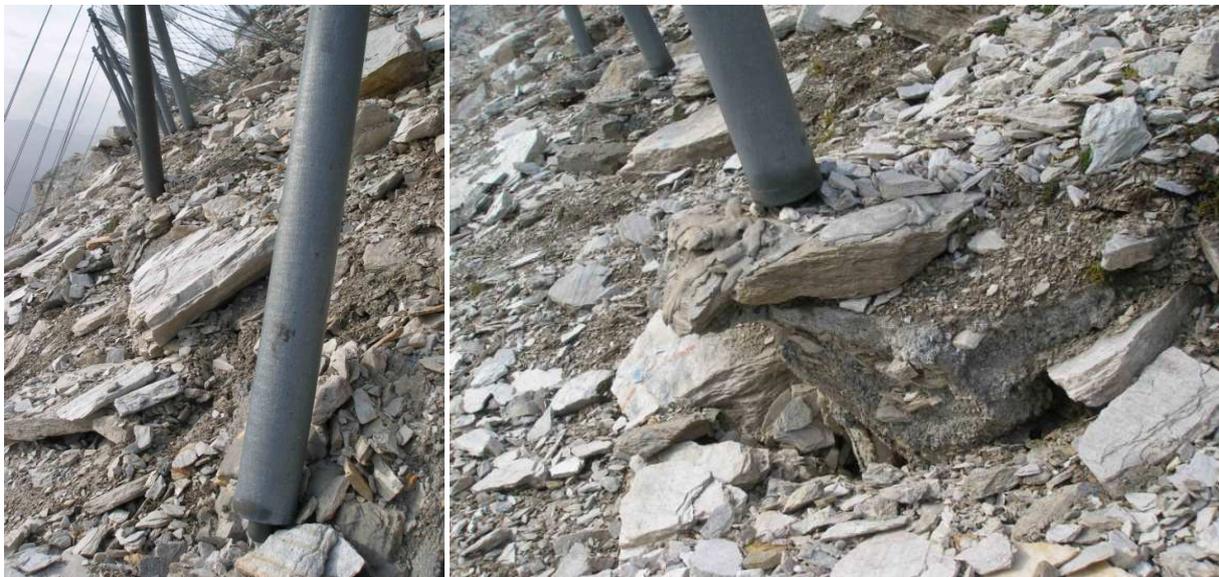
Fig. 4.40 – Dislocated swivel support and disturbed row geometry at Wisse Schijen (left). Tipped and undercut foundation (right).

The main improvements carried out during urgent repairs in 2008 involved the replacement of damaged fixed foundations with floating ones (steel bed plates) under the swivel posts of the snow nets (Fig. 4.41) and the use of specifically developed permafrost grout for anchors. In addition new boreholes were drilled to replace the strongly deformed initial ones. The future development of the snow nets and of the permafrost at this site continues to be monitored and the experience gleaned will be put to use at other avalanche defense sites in the Alps. Technical recommendations for all other types of typical mountain infrastructure in permafrost terrain have recently been published (Bommer et al. 2009, Bommer et al. 2010), as engineering projects in ice-bearing substrates are becoming increasingly challenging under the influence of climate change in the Alps (Phillips et al. 2008, Arenson et al. 2009).

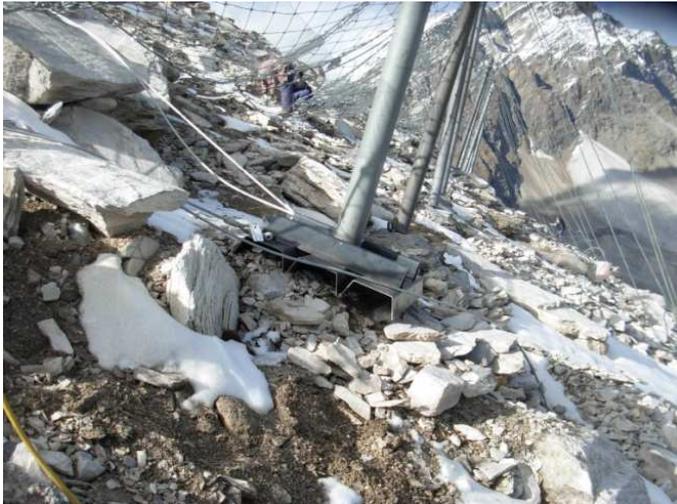
Fig. 4.41 – Repaired snow nets with floating foundations (steel bed plates) in 2008.
